RE: SETTING A PUBLIC HEARING IN CONNECTION WITH THE ESTABLISHMENT OF ZONE OF ASSESSMENT "032" IN THE DUTCHESS COUNTY WATER DISTRICT LOCATED IN THE TOWN OF HYDE PARK

Pinebrook Expansion Water System (County District Zone of Assessment “032”)

**Engineer's Report - Pinebrook Water District Evaluation, prepared by Tighe & Bond, last revised August 2014**

FINAL REPORT  
**Pinebrook Water  
District Evaluation**

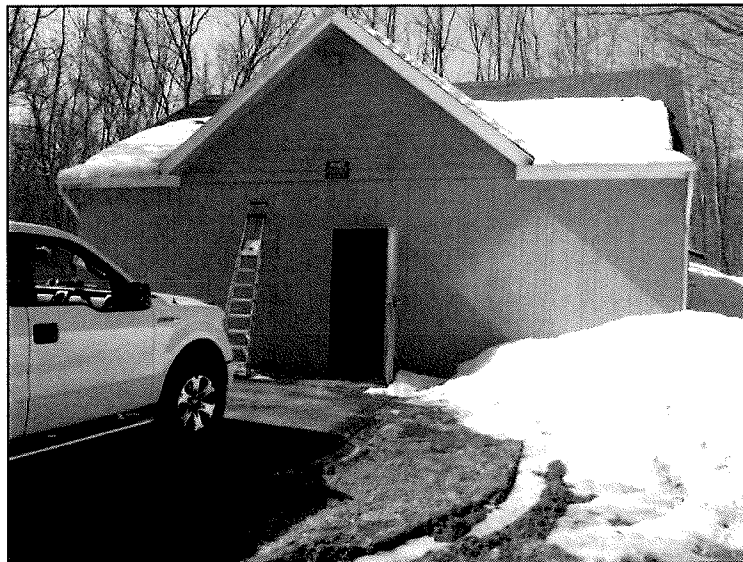
**Figure 2-4 Pinebrook Treatment Facility**

There is no perimeter fencing or other security measures for the facility. Due to the location of the building relative to the road, and small parking area in front, perimeter fencing would not be feasible without blocking the pulloff area. As such, at a minimum, we recommend that door contacts and an alarm system be provided for the facility.

Additional security should also be provided for the remote wells and storage tanks, as detailed in section 2.4.5 below.

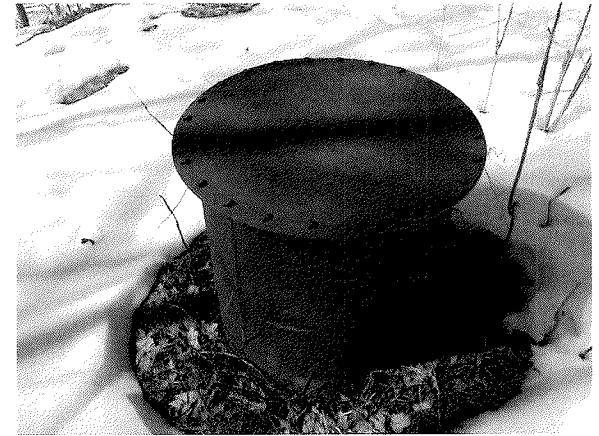
## ■ Site/Civil

- Add door contacts and no trespassing signs
- Provide locking mechanism for tank access manholes
- Consider additional security for remote wells

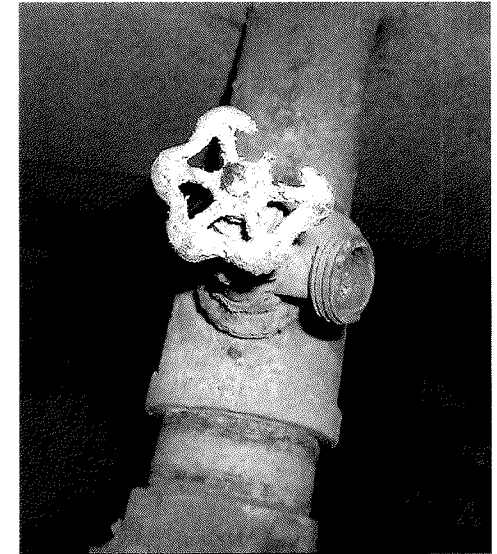
## ■ Process/Mechanical

- Short Term
  - » Replace tank piping (in process)
  - » Replace sample tap
  - » Add/replace pipe supports
  - » Provide permanent tank labels (Immediate)
  - » Provide containment pallets
  - » Provide redundant pump and flow pacing
- Long Term
  - » Replace transfer pumps
  - » Replace chemical tanks
  - » Replace piping

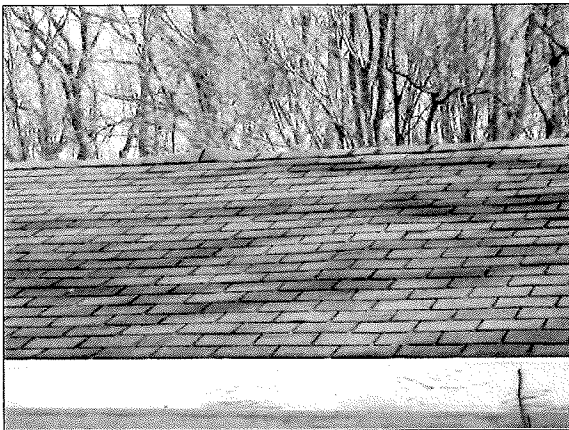
Deteriorated Asphalt Shingle Roof

- Replace asphalt shingle roof
- Clean and paint eave trim
- Replace deteriorated door frame
- Repair deteriorated areas of concrete floor
- Door frame chlorine room in failed condition, replace if door required at opening; clean/paint lintel

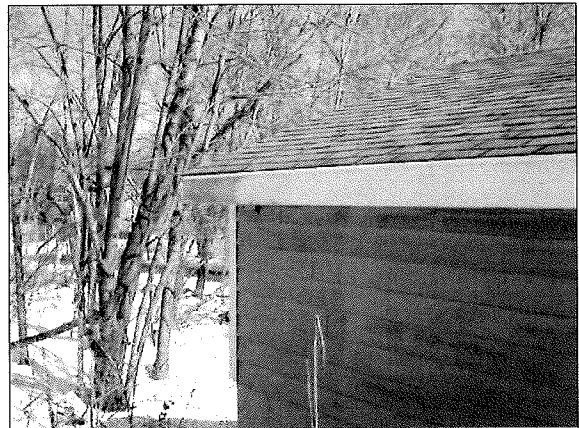
Paint on eave trim in poor condition and no gutter present

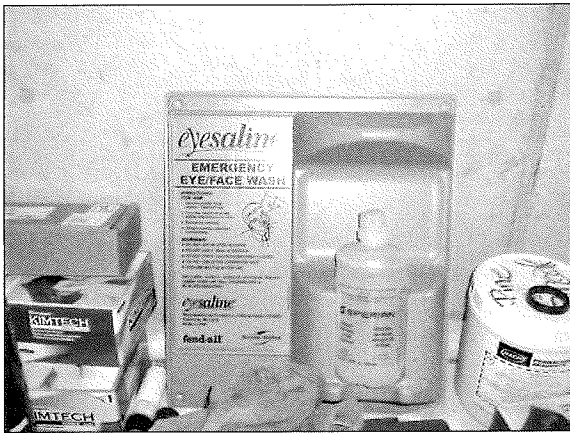
Emergency eyewash bottle

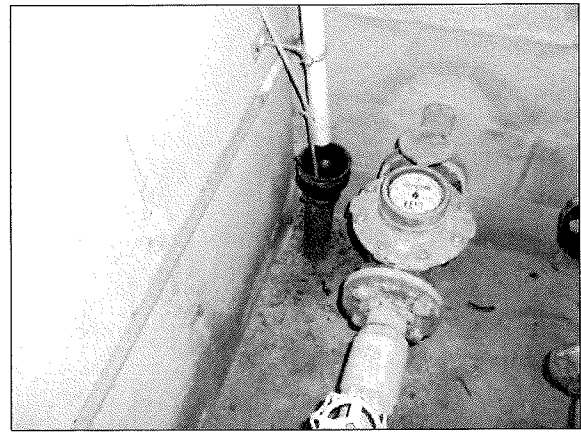
Flow meters

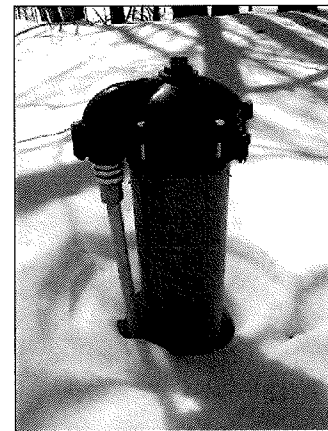
Well 3 lacking level instrumentation and labeling

We recommend that flow testing be completed on the wells to confirm their existing capacity. Following this testing, we recommend that well level instrumentation and individual flow meters be installed in order to monitor well production over time and track the need for well redevelopment or improvements.

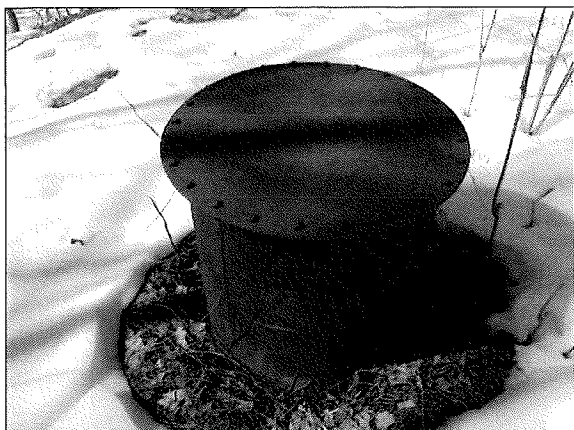
Access Manhole Cover Bolted to the Frames
